Inspection Report Submittal

Facility Name: **PEPCO Benning Road Generating Station**

Inspection Type: **NPDES Compliance Evaluation Inspection**

Re: PEPCO Benning Road Generating Station
NPDES DC0000094 Compliance Evaluation Inspection Summary of Findings

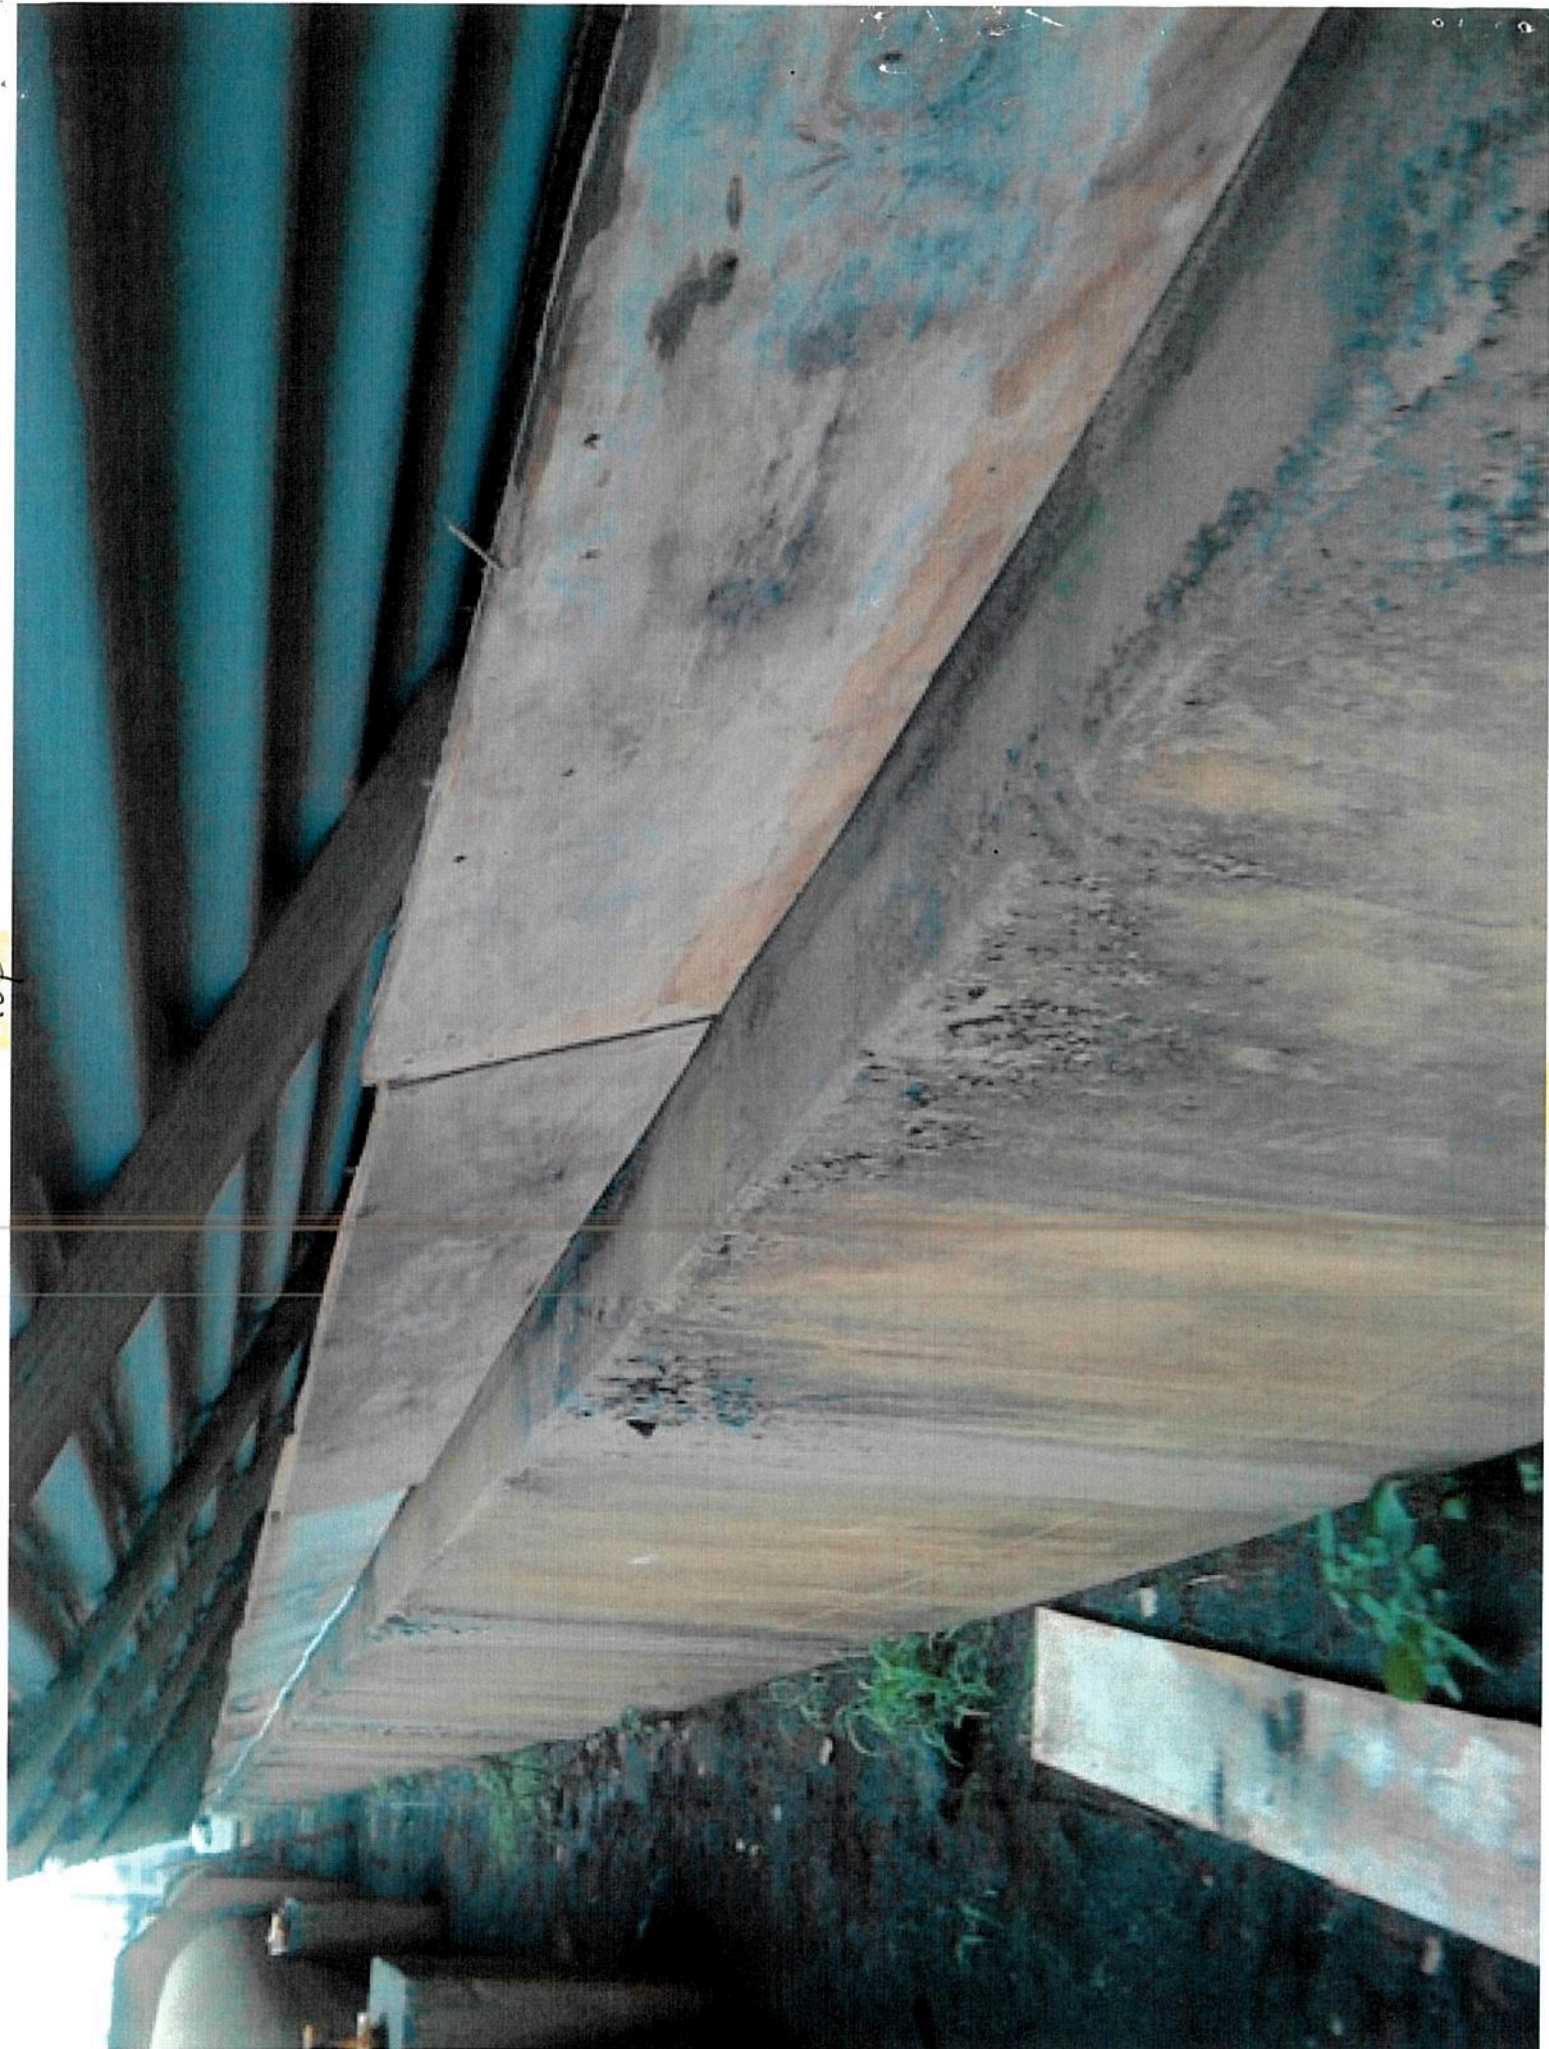
After your July 28, 2011 NPDES inspection at Benning, the Generating Station addressed your concern about the standing water along the fence line resulting from the operation of cooling tower # 15. The cooling tower came offline on Saturday July 30 and was inspected to determine how to remedy the louvers and water leaks. As a result of the inspection, the Plant implemented the following corrective actions:

- Installed plywood beams around the leaking area right above the basin wall, and caulked the beams in place to create a tight seal
- Installed angled boards near the corner of cooling tower basin to redirect any small flow leaks back into the basin
- Adjusted and repaired louvers near where leaks were observed.
